Assessment of Channelizing Device Effectiveness on High Speed/High Volume Roadways

Final Report
July 2007

Sponsored by
the Smart Work Zone Deployment Initiative
and
the Iowa Department of Transportation
(CTRE Project 06-278)

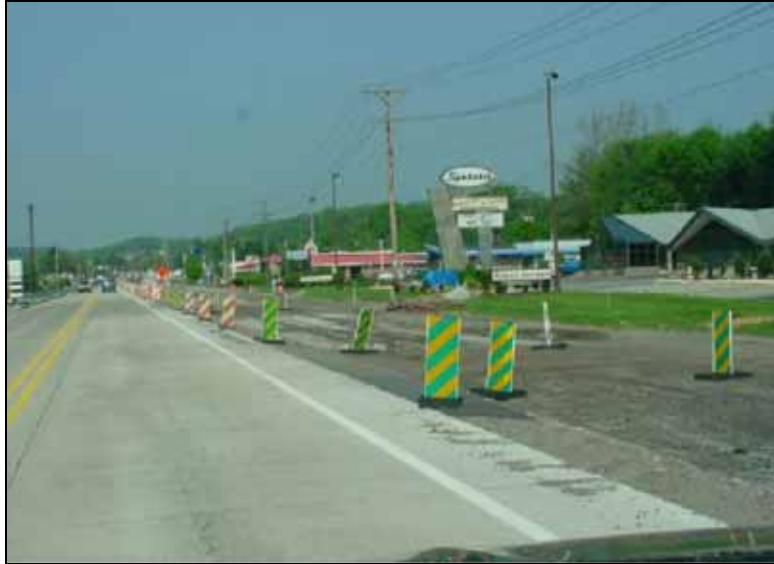
Figure 3. Alternate-colored vertical panels at entrance taper (PennDOT)

In addition to the guidance in Part 6 of the MUTCD described previously, some states have taken advantage of Section 1A.10 of the MUTCD for an opportunity to experiment with design modifications of channelizing devices to enhance driver attention and compliance with work zone TTC. Some examples of taper experiments used in Pennsylvania are shown in Figures 3 and 4. Figure 3 shows alternative green and yellow panels, instead of the standard orange panels. Another alternative configuration is shown in Figure 4, using green and white striped drums at the exit taper.

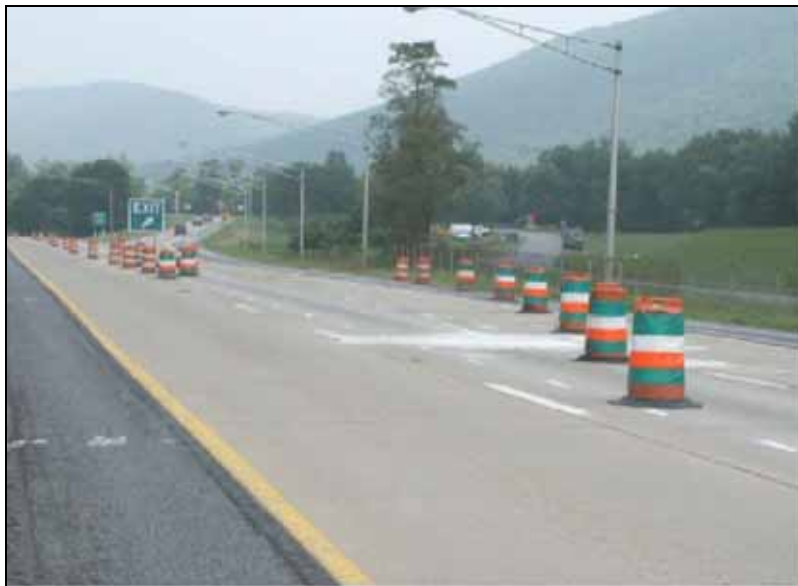
Figure 4. Alternate-colored drums at exit taper (PennDOT)

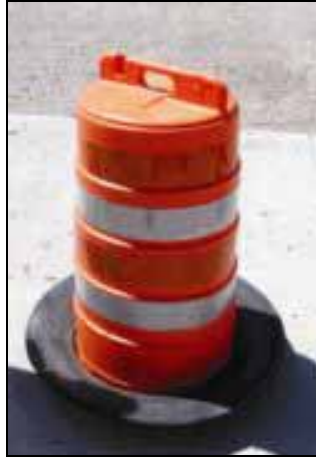
Figure 7 illustrates the standard drum-like channelizers that are generally used in work zone areas to provide longitudinal channelization within the activity area if their larger size and additional retro-reflective area are deemed appropriate. Drum-like channelizers are not generally used in areas with limited lateral clearance. When specified, quantities may be calculated and shown in the project plans.

Figure 7. Drum-like channelizer

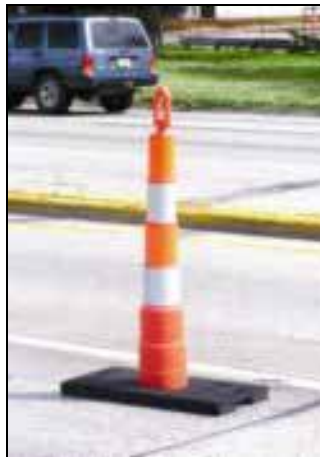
Figure 8 illustrates the 42 in. channelizers, sometimes referred to as “grabber cones”. These channelizing devices are used in work zones and can be used in ramp areas, intersections and areas with limited lateral clearances. These types of channelizers may be used in daytime or nighttime operations in many states. When specified, quantities may be calculated and shown in the project plans.

Figure 8. 42 in. channelizer

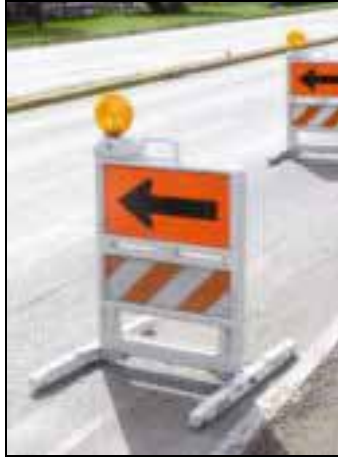
Figure 9 illustrates the direction indicator barricades (DIB) that can be used instead of other channelizers in merging tapers, as DIBs provide direction and have a larger visual target area for motorists. DIBs, however, are not recommended for shifting tapers. When specified, quantities may be calculated and shown in the project plans.

Figure 9. Direction indicator barricade

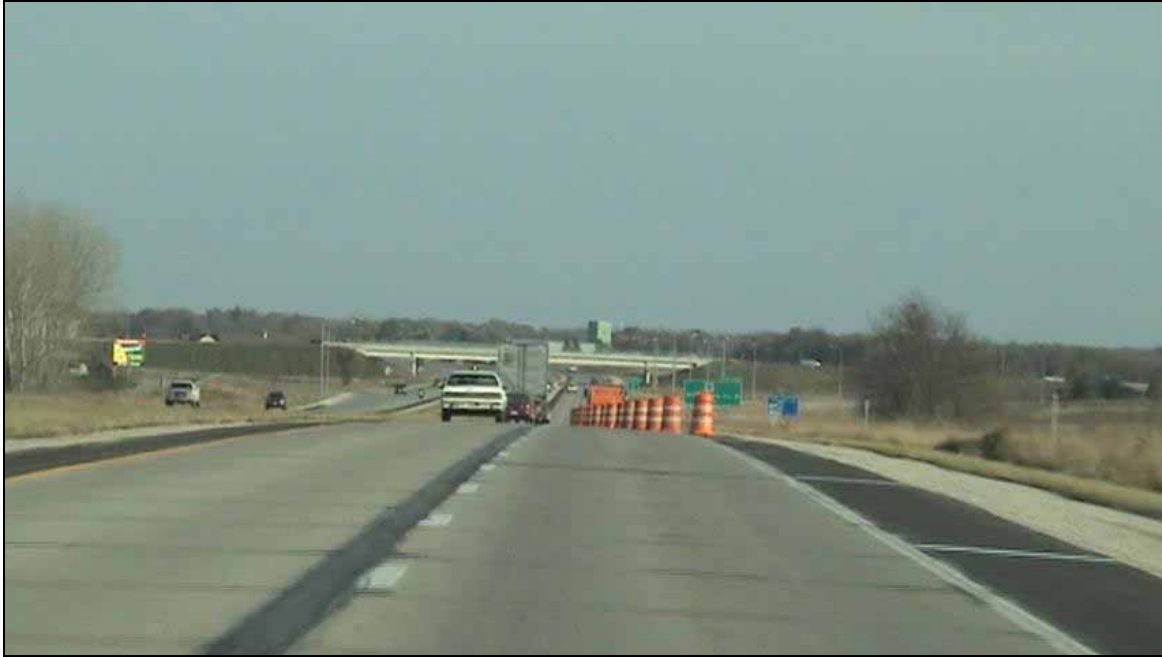
Figure 10. Drums at 60 ft.

The following three figures show different work zone configurations using different channelizing devices. Figure 10 shows the base line work zone configuration, with the standard drums set at 60 ft. intervals. Figure 11 shows the 42 in. channelizers set at 60 ft. intervals. Figure 12 shows the 42 in. channelizers, or “grabber cones,” set at 40 ft. intervals.

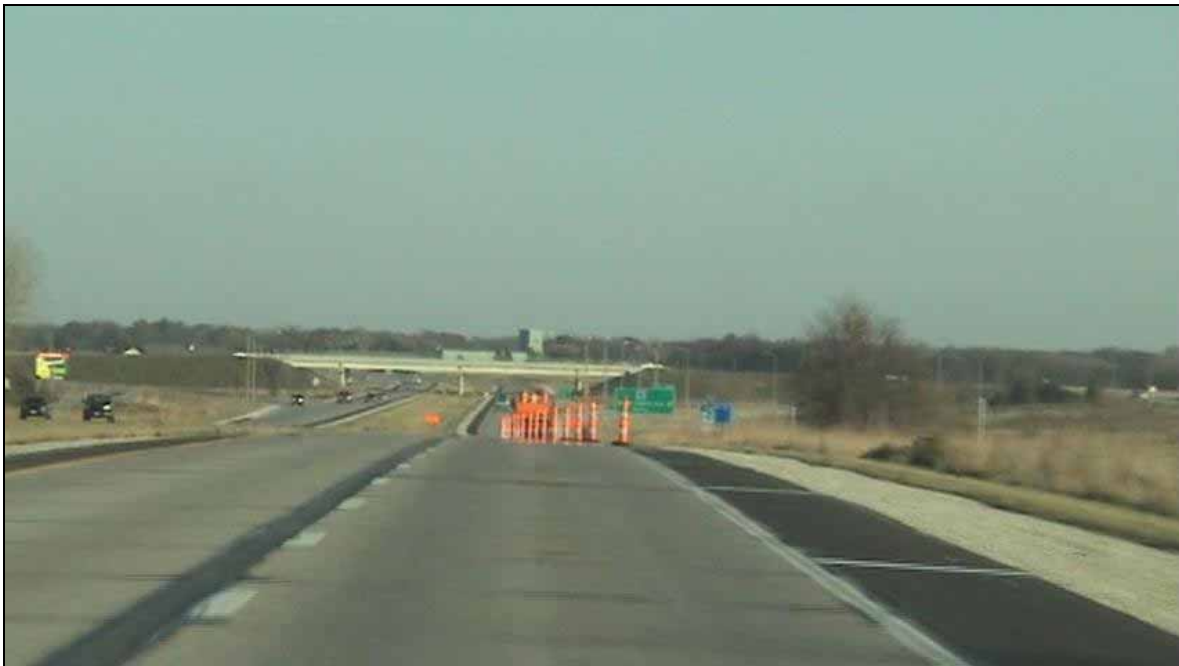
Figure 11. 42 in. channelizers at 60 ft.

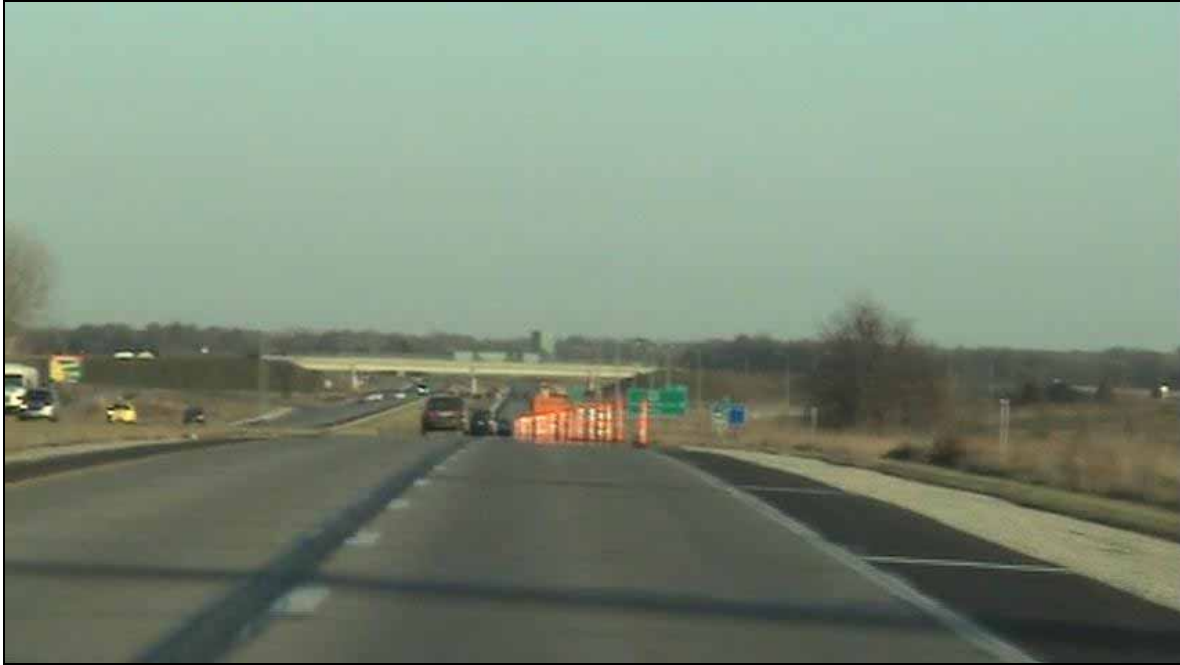
Figure 12. 42 in. channelizers at 40 ft.

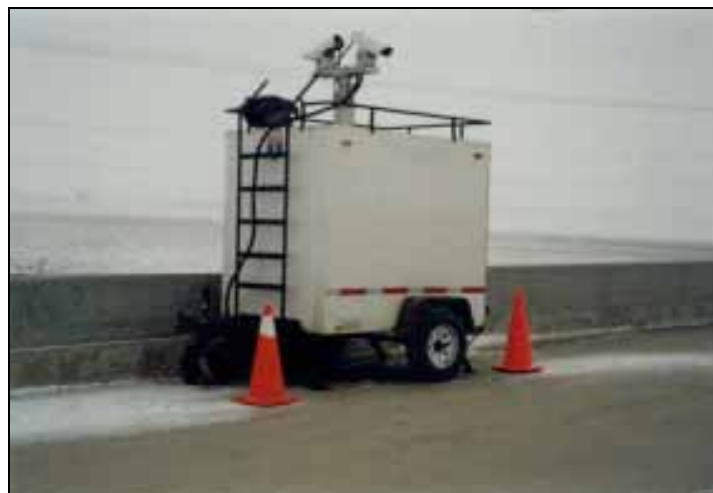
Figure 13. AutoScope video traffic detection system

US 30 traffic flow characteristics were collected during four days from October 30 to November 2, 2006 from the Y Avenue overpass over US 30 near Ames, Iowa. The data were collected with the AutoScope wide-area video detection system, which consists of a control unit, image sensors (or video cameras), and supervisor computer/software. For this research, two video cameras were mounted on a trailer and directly connected to the AutoScope control unit. Figure 13 shows the AutoScope trailer, cameras, and control unit. Traffic flow images were recorded with the cameras in the field and then stored on videotape using the electronic equipment contained in the enclosed trailer (see Figure 14).

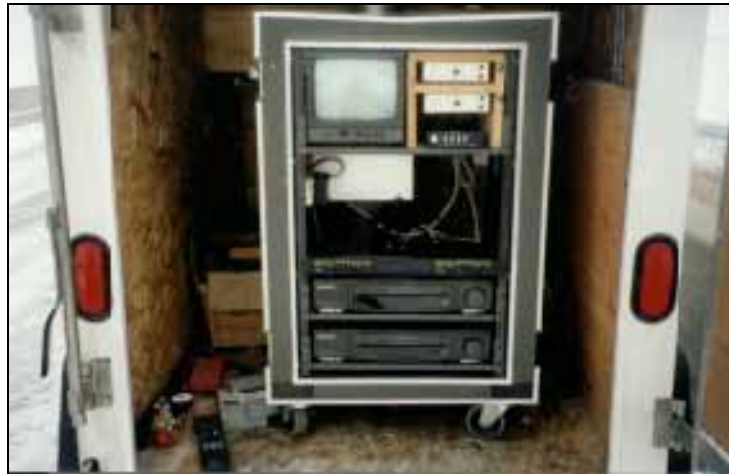
Figure 14. Video detection equipment

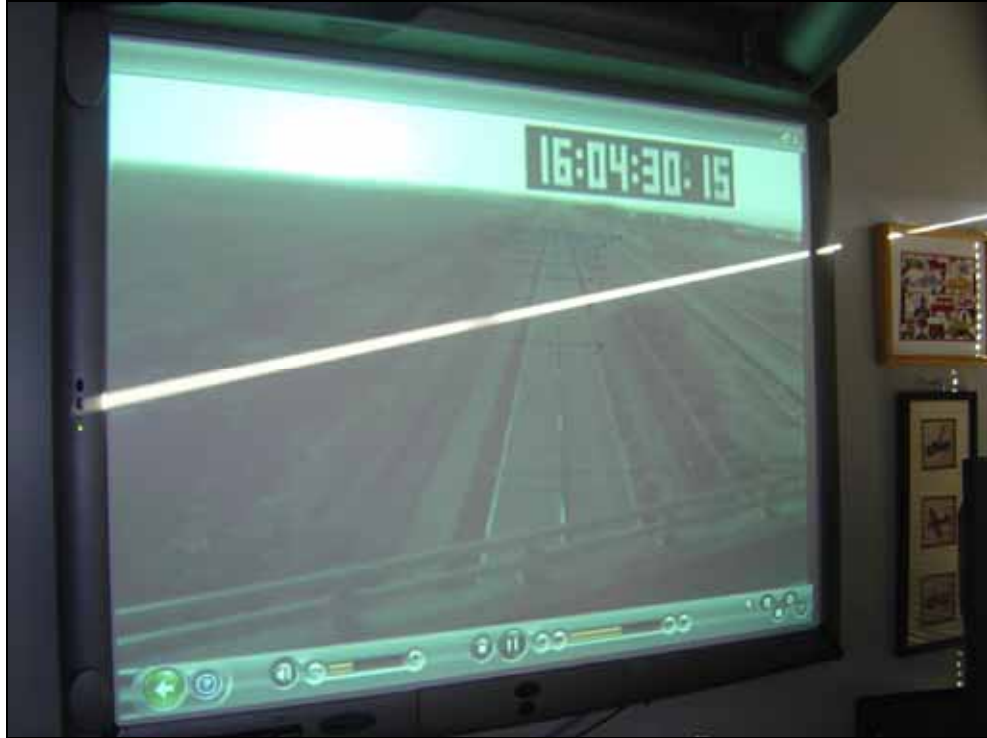
Figure 15. Video copied to DVD, projected on large screen

A large amount of data post-processing was conducted following data collection. The video images taken each day were copied and stored to DVD for added resolution and ease of analysis. The DVD images were then projected onto a large screen so that the images were more easily seen. The traffic was observed and analyzed from this point. Figure 15 shows an image as copied to DVD.

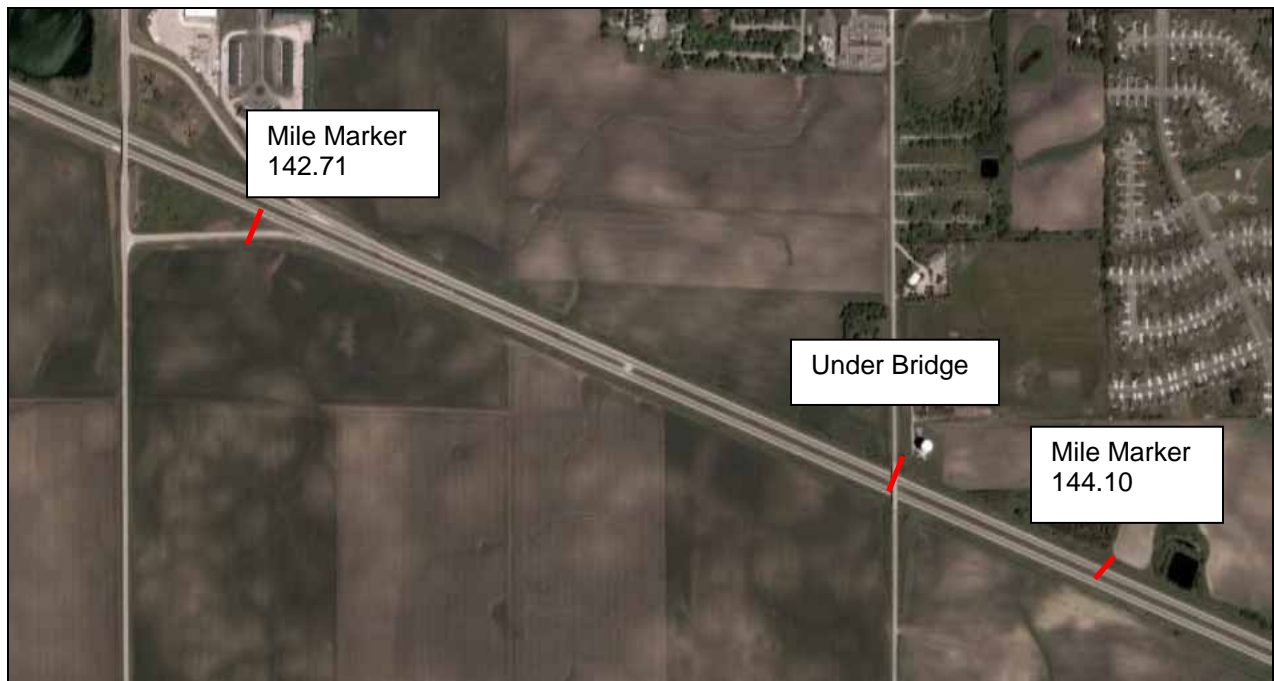
Speed was also analyzed for each channelization setup. Three sets of pneumatic road tube counters were placed on US 30 at various locations to gather traffic data. The posted speed limit for this section of US 30 is 65 mph. For this study, one set of tube counters was placed upstream, approximately one mile ahead of the work zone at mile marker 142.71. The second set was placed just under the Y Avenue Bridge, approximately 1,000 ft. from the beginning of the taper. The third set was placed approximately 1/4 mile from the end of the work zone at mile marker 144.10. The speed data show a general decrease in traffic speed through the work zone area. Figure 19 shows the approximate placement of the pneumatic road tubes on US 30 for this study. The tubes provided valuable speed and traffic data for the duration of the study.

Figure 19. Placement of pneumatic road tubes
